# An Analysis of Nondestructive Evaluation Techniques for Polymer Matrix Composite Sandwich Materials

1. AGENCY USE ONLY (Leave blank)		2. REPORT DATE June 2006		3. REPORT TYPE AND DATES COVERED Technical Memorandum
4. TITLE AND SUBTITLE An Analysis of Nondestructive Evaluation Techniques for Polymer Matrix Composite Sandwich Materials			5. FUNDING NUMBERS  WBS 698259.02.07.03

9. SPONSORING/MONITORING AGENCY NAME(S) AND ADDRESS(ES) National Aeronautics and Space Administration Washington, DC 20546-0001			10. SPONSORING/MONITORING AGENCY REPORT NUMBER  NASA TM-2006-214349

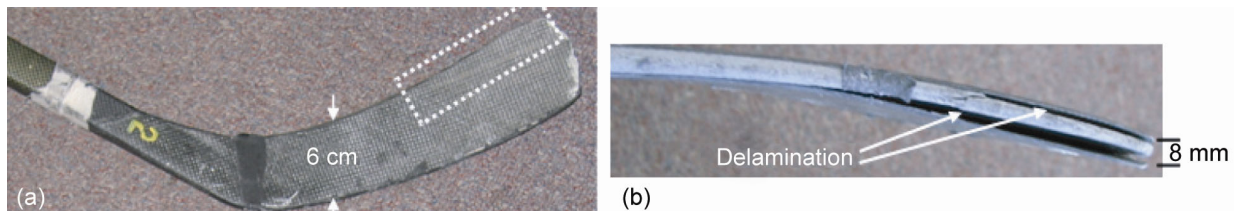
Figure 1.—Photographs of a hockey blade with a delamination extending over approximately half the blade: (a) an overall image of the hockey blade and (b) a side view from the upper right hand side of the blade illustrating the delamination.

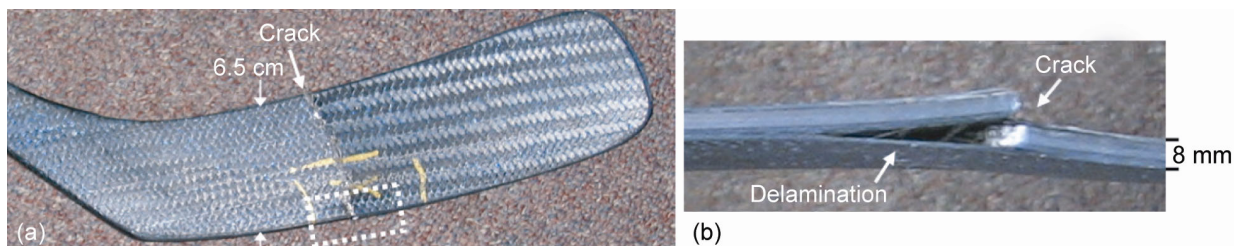
Figure 2.—Photographs of the hockey blade with a crack through the thickness of the foam and one of the face sheets: (a) an overall image of the hockey blade illustrating the location of the crack and (b) a side view from the bottom of the blade depicting the morphology of damage near the crack.

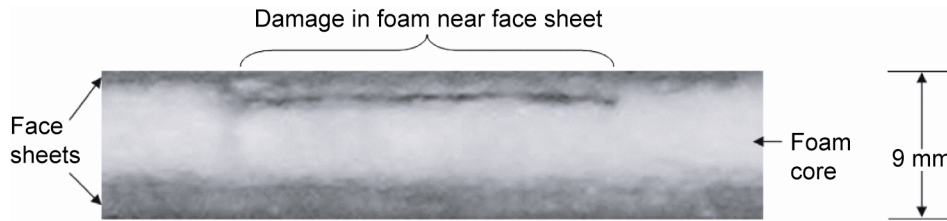
Figure 4.—A side view of the sandwich material in the flat panel illustrating the intentional damage inserted into the foam core.

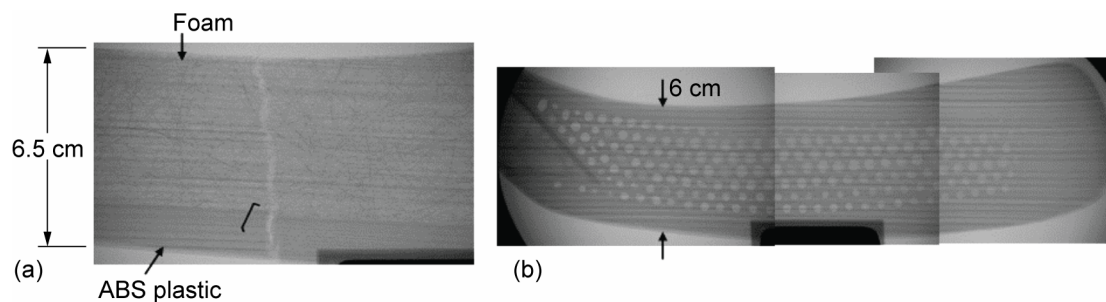
X-ray was able to detect structural elements that affected absorption characteristics in a component. Figure 8 represents two x-ray images from two individual hockey blades. Figure 8(a) is an image from the blade with a crack through the foam core and one of the face sheets while figure 8(b) depicts a composite image of one of the hockey blades with a honeycomb ABS plastic core. The blade with the honeycomb core was used in play and had a delamination at its tip. As shown in the images, x-ray detected many structural elements including structural staples (fig. 8(a)), fine glass fibers at the foam core and face sheet interface (fig. 8(a)), the honeycomb structure in the core (fig. 8(b)), and material differences between the foam core and the ABS plastic core at the blade edge depicted as a grayscale color change (fig. 8(a)). Both images also illustrate the axial fibers along the length of the hockey blade. It should be noted that neither image depicts the delaminations in these two blades. The x-ray image in figure 8(a) is from the cracked blade depicted in figure 2, which had a delamination on the backside of the hockey blade.

Figure 8.—X-ray images from the center of a hockey blade with a crack in the foam and through one of the face sheets (a) and a composite image of a whole blade used in play with a plastic honeycomb core and a delamination at the tip (b).

Real-time x-ray was not able to detect delaminations in the face sheet or between the face sheet and the foam core. For example, figure 8(b) depicts an x-ray image of a hockey blade with a delamination at the blade tip which was detected with shearography (fig. 11(b)) and with pulsed thermography in figure 10. The delamination near the crack in the hockey blade depicted in figure 8(a) went undetected as well. X-ray acquires an averaged response through the thickness of a component and is sensitive to density and thickness changes. Since material was not lost due to the delamination, it went undetected.

In this paper the term crack refers to a planar defect that is parallel to the observer's line of sight. Real-time x-ray detected the crack that went through one face sheet and the foam core, as shown in figure 8(a). However, a crack that was only in the foam core was not detected. The hockey blade with the delamination extending over half the blade also contained a crack that was in the foam core that went undetected with x-ray. The density of the foam may have been too low for the x-ray image to differentiate it from the surrounding air.

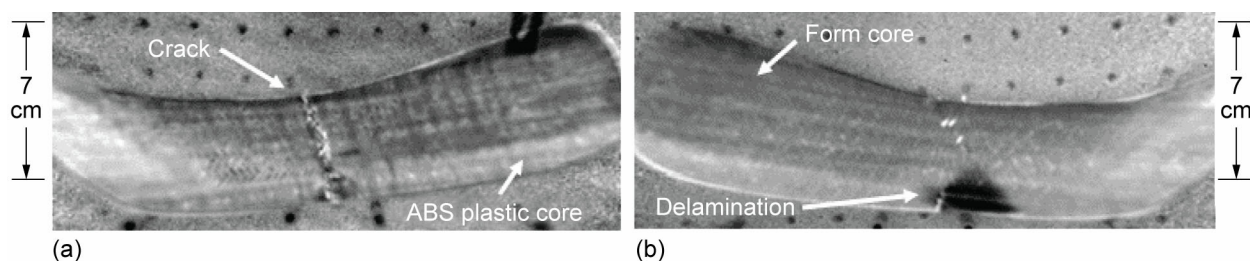
Figure 9.—Thermal derivative images from the front side (a) and back side (b) of a hockey blade with a crack through the foam and one of the face sheets illustrating subsurface material differences, surface conditions and damage detected with pulsed thermography.

Figure 9 illustrates thermal derivative images from the hockey blade with a crack in one of the face sheets and in the foam core. The crack was detected in the thermal derivative image from the side with the optically visible crack, as shown in figure 9(a). From the side where the crack was not optically visible the crack was not detected. However, the response from the crack may have been masked by the response of the delamination. Also, the crack in the foam only was not detected with thermography.

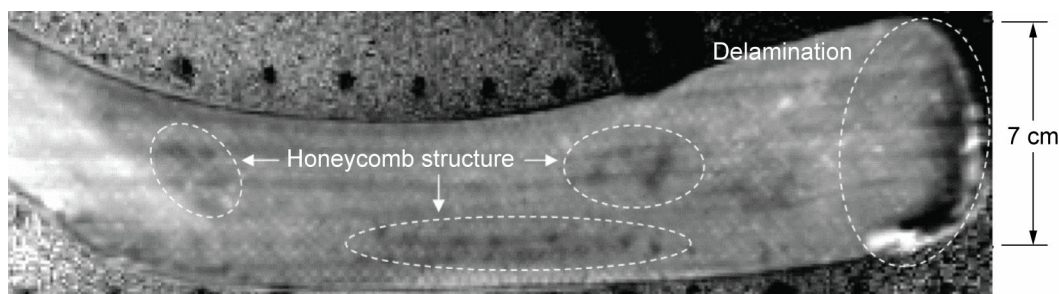
Figure 10.—Thermal derivative image from the front side of the hockey blade with the honeycomb core and a delamination at the blade tip.

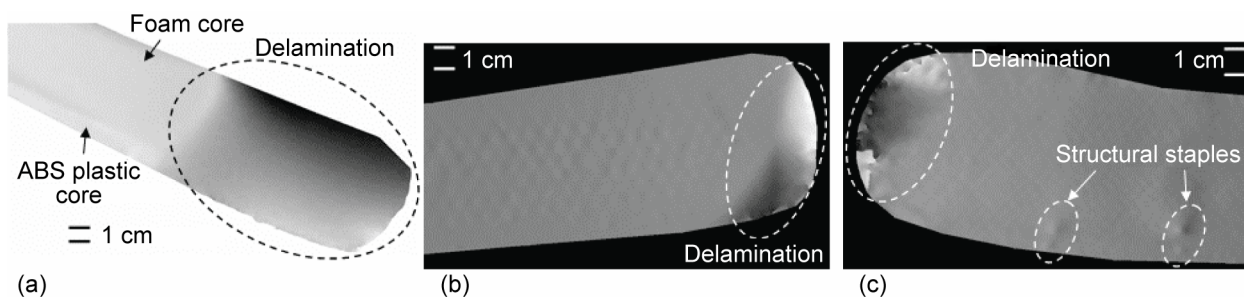
Figure 11.—Shearography images from the hockey blade with a delamination over half the blade (a), the hockey blade with an ABS plastic honeycomb core and a delamination at the tip (b), and a hockey blade containing structural staples and a delamination at the tip (c).

Shearography also detected delaminations in the face sheet or between the face sheet and the foam core. Figure 11 illustrates shearography images from three blades with delaminations. Typically defects, or structurally weaker regions, are indicated with a “butterfly” pattern having alternating contrast levels over the defective region. The patterns shown in figure 11(b) and (c) over delaminated areas are most reflective of this type of damage indication. The damage in the blade depicted in figure 11(a) was extremely severe and easily detected with shearography. Although no images are presented here, shearography was also capable of detecting delaminations on the side opposite of, or furthest from, interrogation.

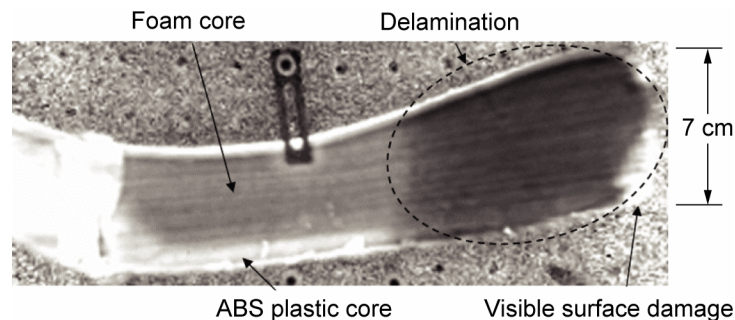
Pulsed thermography detected delaminations in the face sheet or between the face sheet and the foam core. The delamination illustrated in figure 12 was between the face sheet and the foam core. The delaminated region appears as a dark gray or black region which corresponds to a slower cooling rate in the thermal derivative image. Figure 9(b) shows a thermal derivative image from the back side of the cracked hockey blade with the delamination. This delamination, identified in black, also occurred between the face sheet and the foam core and was not detected from the front side of the hockey blade (fig. 9(a)) with pulsed thermography. Figure 10 presents a thermal derivative image from the hockey blade with the honeycomb core and delaminations at the blade tip. The delaminations are represented by the black region at the tip of the blade.

Figure 12.—Thermal derivative image from the hockey blade with a delamination between the core and the face sheet over approximately half the blade. This blade had a foam core and ABS plastic along the bottom edge of the core.

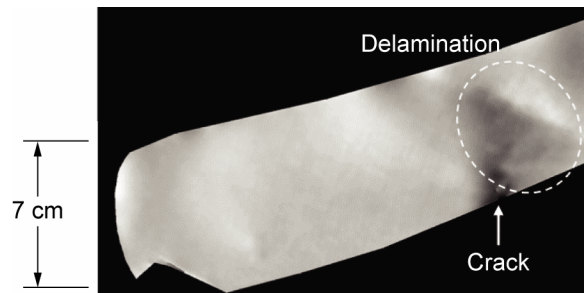
Figure 13.—Shearography results from a hockey blade with a crack through one of the face sheets and into the foam core. The crack and the delamination were detected and shown in the image.

Figure 13 depicts the shearography results from the blade with a crack through one of the face sheets and into the foam core. These results were acquired from the side of the hockey blade where the crack was not optically visible. The crack and the delamination were detected together in this image. The crack in the core of the hockey blade with the large delamination was not detected with shearography due to the response of the crack being masked by the response of the delamination.

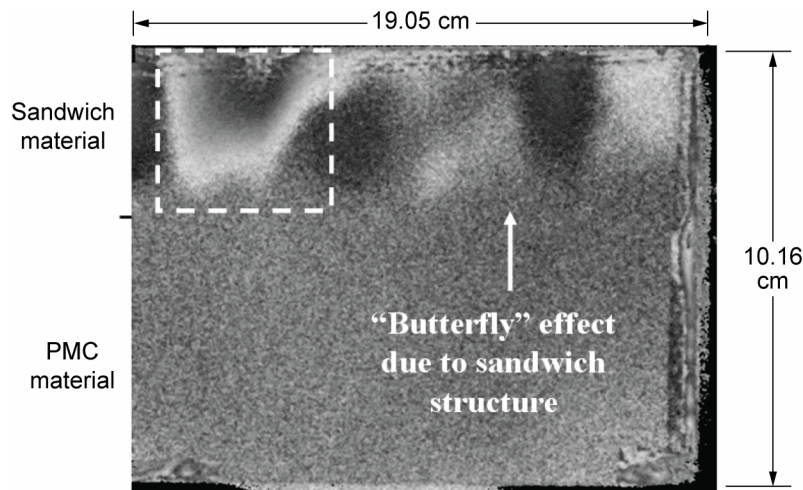
Shearography was able to detect the damage in the foam core as shown in the image from the flat panel in figure 14. In the image, shearography also detected the presence of sandwich material as an alternating pattern of black and white, which is often referred to as a “butterfly” pattern. This pattern indicates that the local stiffness and strength of the region with the sandwich material differs from that of

Figure 14.—Shearography results from the flat panel illustrated in figure 3 highlighting the detection of the damage in the foam core.

the region consisting of the PMC. The shearography response in the region of the panel where damage was intentionally inserted into the foam core was shown as a darker black region surrounded by a lighter white region. It is highlighted by a dashed square in the figure. Shearography also was able to detect the core damage from the opposite side of the panel.
